# Hengistbury Head – Repair & Recovery 2014

Overview & Scrutiny Panel  
12<sup>th</sup> March 2015

# Project Overview

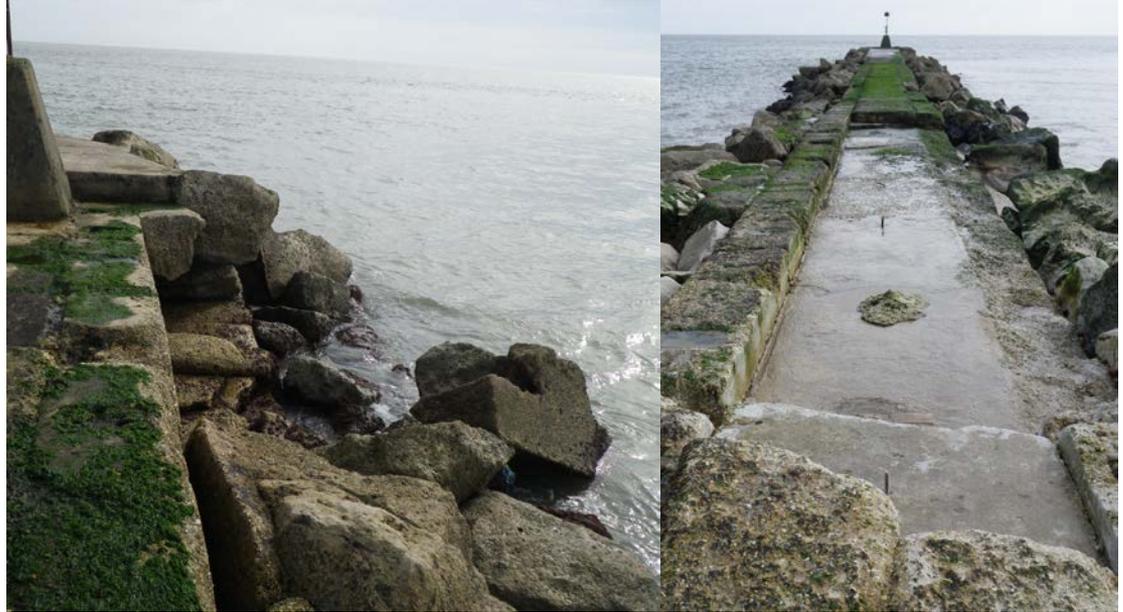
# Hengistbury Head Long Groyne, Storm damage

- Rock armour on the western side reduced as settlement occurred.
- Rock armour on the eastern side settled.
- Concrete deck slabs washed of deck and deposited to the east.
- Main concrete structure damaged where rock armour has been displaced.

- The repairs consisted of repacking of existing armour and the installation of additional 5-7 tonne rock armour to the western and eastern sides of long groyne.
- A total of 1500 tonnes of additional rock armour was placed.
- New beacon was installed to replace existing damaged beacon.

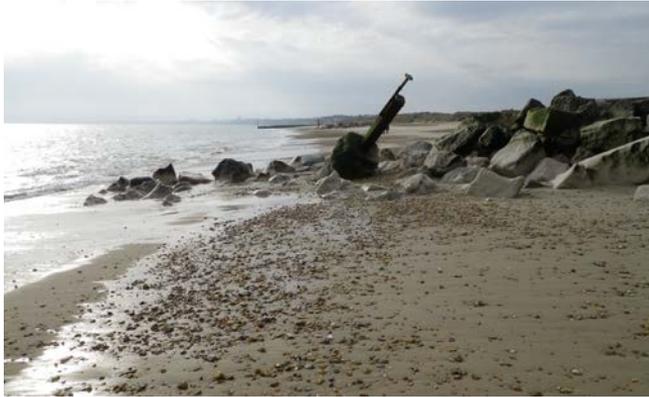
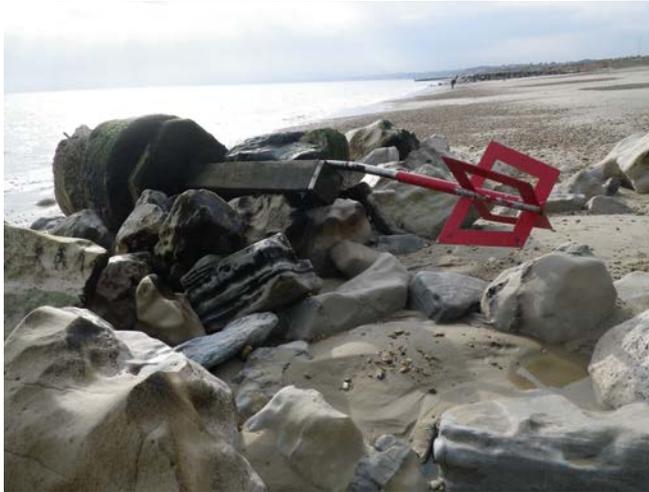
# Rock Groynes 55, 56 & 57, Storm damage

- Rock armour on the roundheads of all three groynes were displaced landward or had been lost presumably buried in the beach either side of the groynes.
- The navigation beacon was slightly damaged on groyne 55.
- The navigation beacon was badly damaged on groyne 56.
- The navigation beacon was washed out on groyne 57.
- The damage was progressively worsened to the east

- The repairs consisted of repacking the existing armour and the installation of additional 5-7 tonne rock armour to the roundheads of all three groynes.
- A total of 3300 tonnes of additional rock armour was placed to all three groynes.
- New beacon structures have been built in the roundheads with new beacons attached.

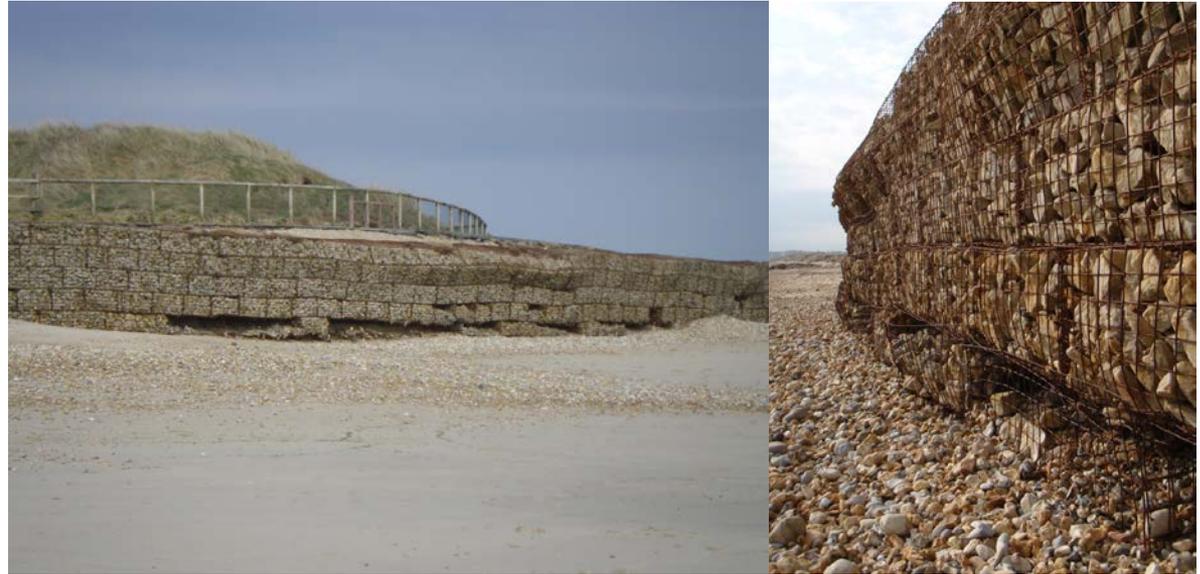
# Gabions at Double Dykes, Storm damage

- Gabion baskets were abraded and corroded.
- Considerable amount of rock had been washed out of the gabion baskets.
- Several empty baskets had been crushed from full baskets above.
- Top tier of gabions had settled.

- 7 tiers of gabion baskets over a 53m length have been replaced.
- Approximately 50% of the existing stone was recycled back into the new baskets.
