FLOODING IN BOURNEMOUTH  
23<sup>rd</sup> June 2016  
Section 19 Report (Floods and Water Management Act 2010)  
for  
Flooding Advisory Group

Final 16/12/2016

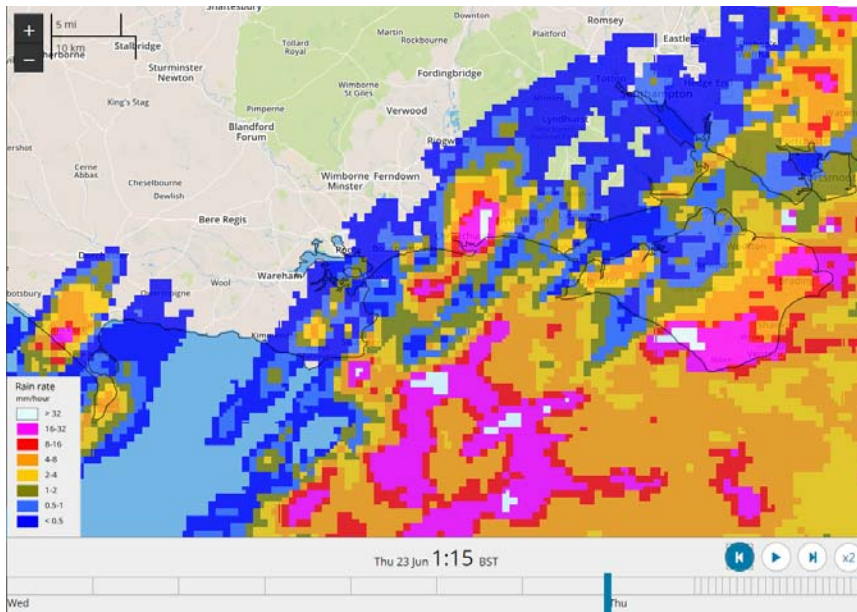
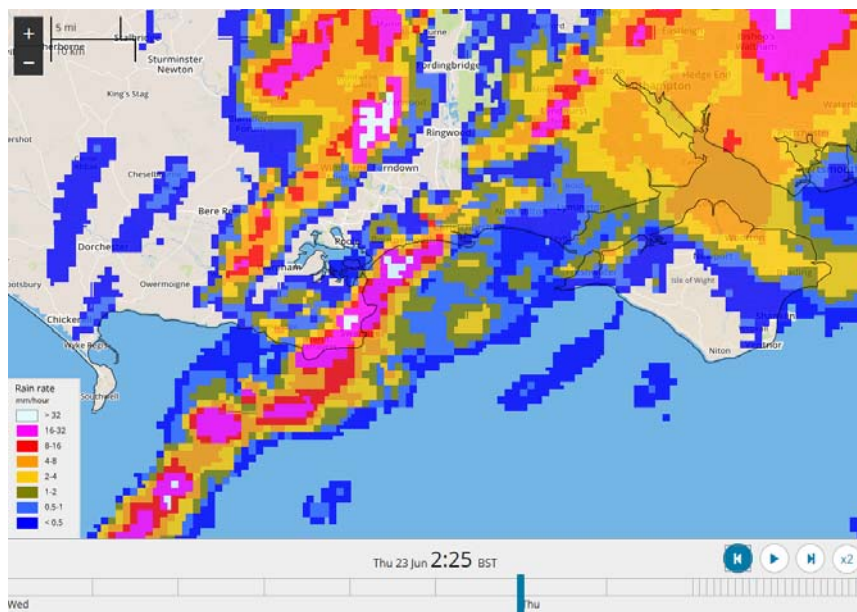
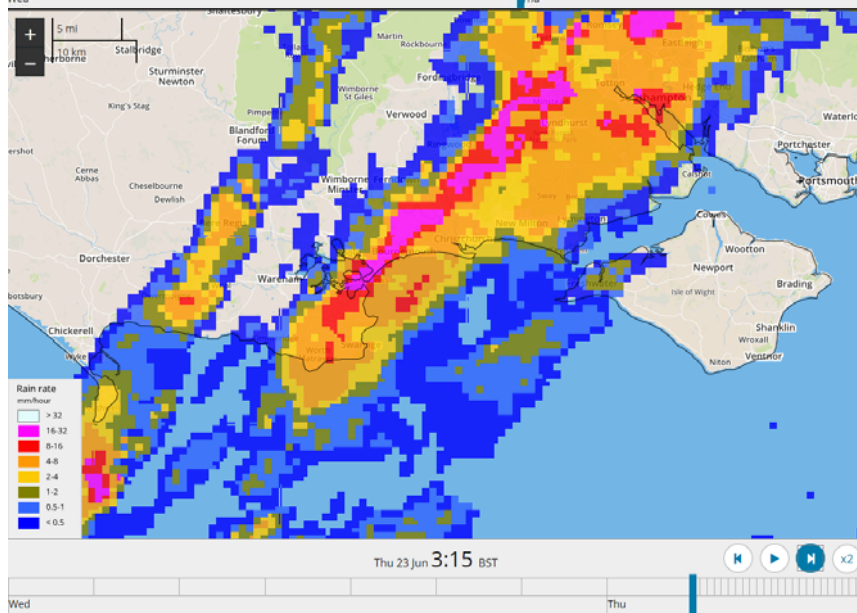
3.3 The following shows “snap shots of the actual rainfall radar which shows that the vast bulk of the rainfall was mainly out to sea but just for a while “drifted” in land. The rain gauges suggest that the heaviest rainfall was actually in Southbourne and the Strouden areas of Bournemouth (confirmed by the Wessex Water rain gauge at Berry Hill). THERE WAS NO REPORTED FLOODING IN THESE AREAS.

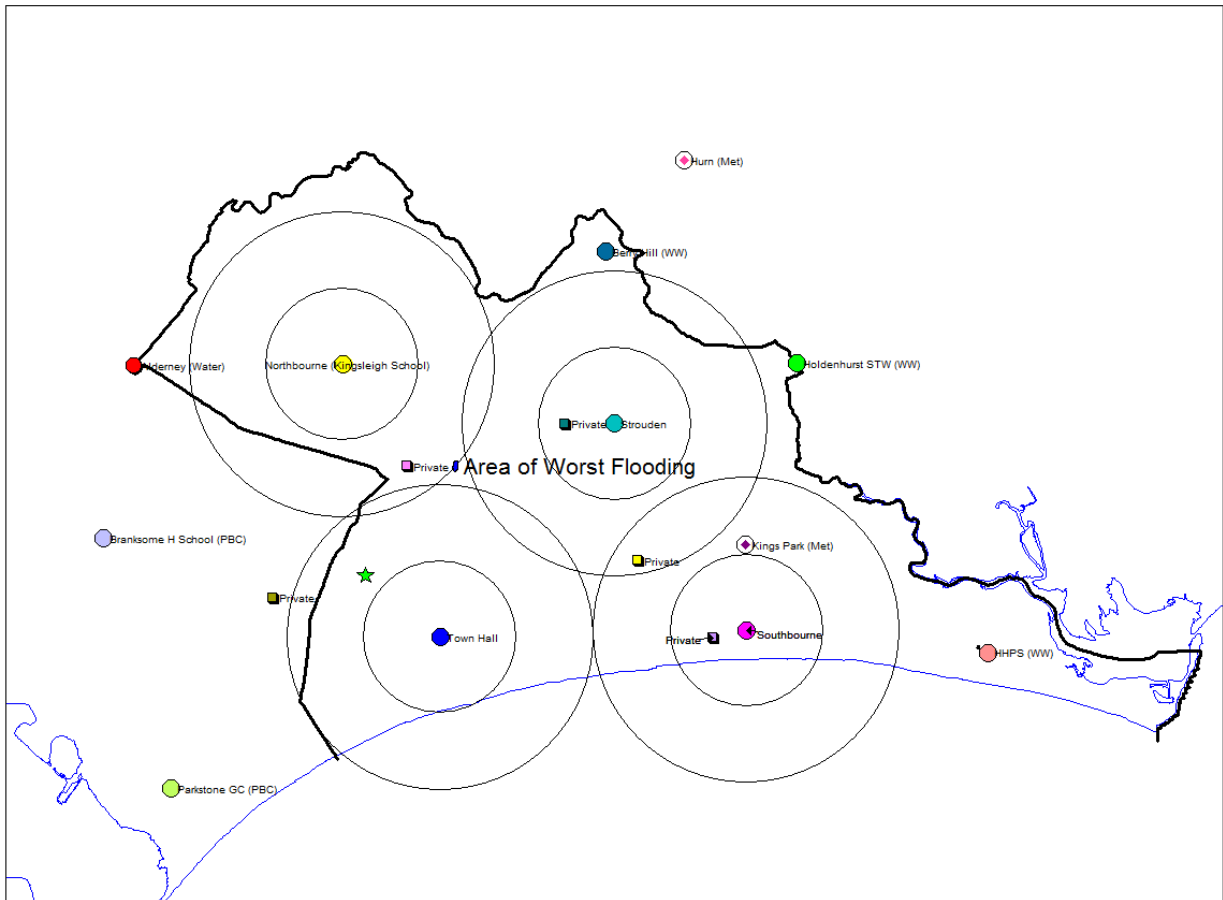
## Existing Rain Gauges in and around Bournemouth (not to scale)

(Rings are 1km and 2km respectively from the Bournemouth Raing Guages. The private rain gauge which was near by does not seem to be currently reporting)

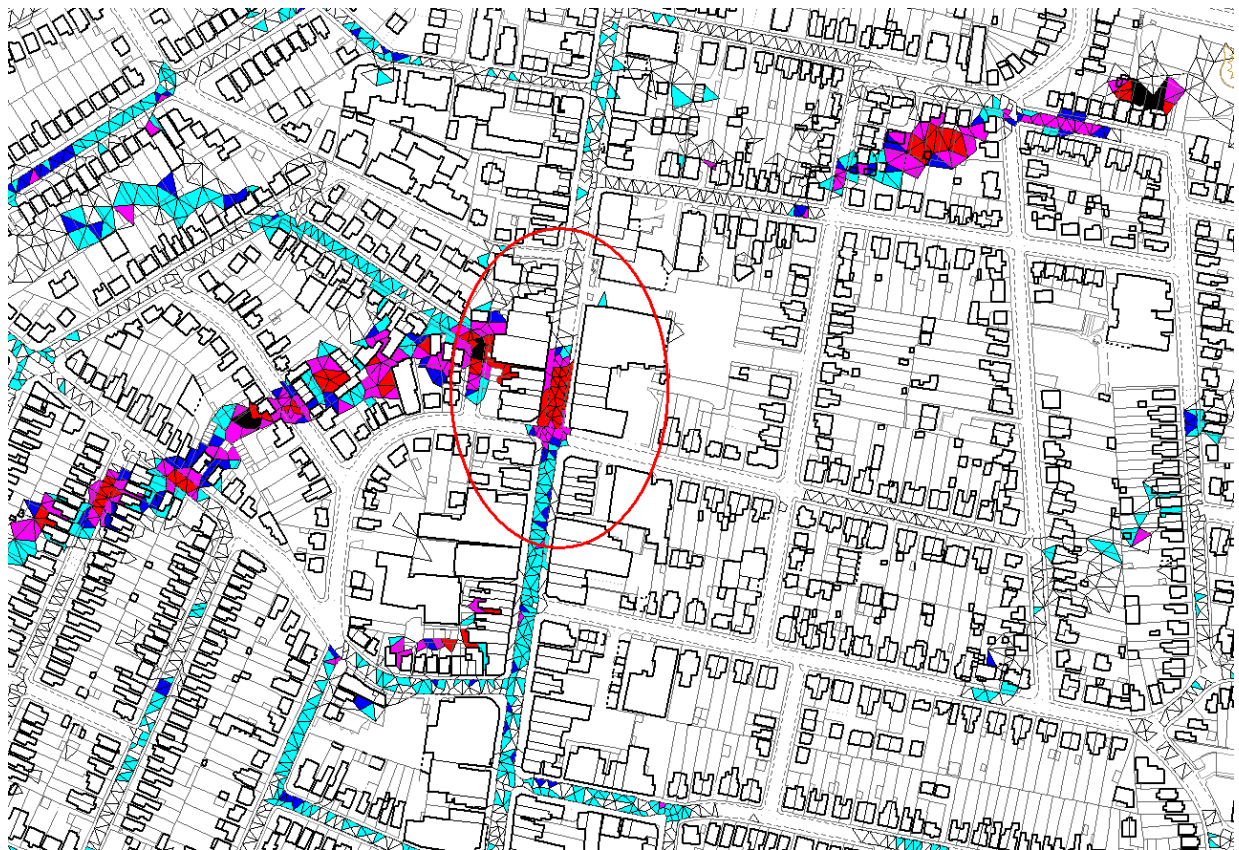
- 4.8 All the currently available surface water flood models show this is a high risk area. Below are the results for a 1 in 100 year storm using the latest available full Infoworks Model developed jointly with Wessex Water (The pale blue is depth 50-100mm, dark blue 100-150mm, purple 150-300mm red 300-500mm and black exceeding 500mm).
